Sustainable Concrete Restoration Using Microbial-Induced Carbonate Precipitation Technology: Insights from Laboratory and Field Applications

Hazlami Fikri Basri^{a*}, Devithera Saravanan^a, Syafiqah Mohd Sani^a, Armstrong Ighodalo Omorogie^b, Adharsh Rajasekar^c, Siti Munira Jamil^d, Shafiq Ishak^e, Tariq Ouahbi^f

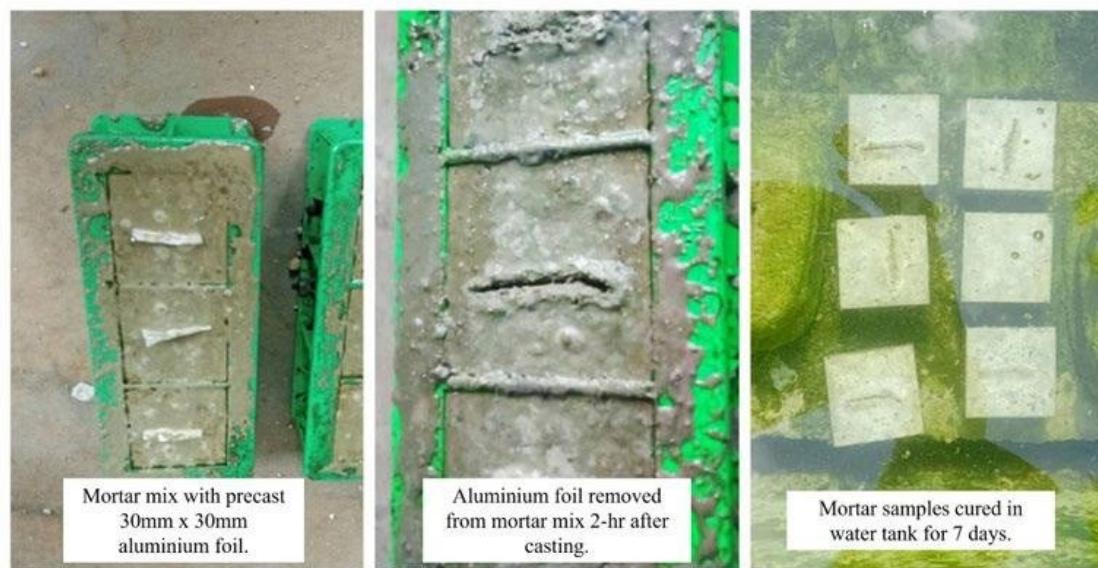
Figure 1. Mortar samples with precast crack preparation

Mortar samples were prepared using Ordinary Portland Cement (OPC), river sand, and water. A total of 648.6 g of cement and 1621.6 g of sand were dry-mixed in a large container to achieve uniform distribution. Subsequently, 259.5 mL of water was gradually added over five minutes while mixing to obtain a homogeneous and workable mortar. The fresh mortar was then cast into lightly oiled plastic

molds to form two specimen geometries: cubes (50 mm × 50 mm × 50 mm) and cylinders (100 mm height × 50 mm diameter). Compaction was carried out using a concrete vibrating table (MTM Precision Sdn Bhd, Selangor, Malaysia) to eliminate entrapped air and ensure good consolidation. Two types of cracks were introduced: controlled cracks in cube specimens and uncontrolled cracks in cylindrical specimens. Controlled cracks were created by embedding a 1 mm × 30 mm × 30 mm aluminium foil strip at the mid-depth of one cube mold during compaction. After two hours of initial setting, the foil was carefully removed to form a uniform 1.0 mm artificial crack, ensuring consistent crack geometry across all cube samples. In contrast, uncontrolled cracks were generated in cylindrical specimens using a compression machine (NL 000 X/006, NL Scientific Instruments Sdn. Bhd., Selangor, Malaysia). A load of 0.10 kN was applied over nine seconds to induce cracking along the specimen surface, producing irregular patterns that simulate realistic field crack development. All specimens were left to cure in molds at room temperature for 24 hours, demolded, and labeled for identification as shown in Figure 1. Curing was then continued by submerging the specimens fully in a water tank for seven days. After curing, the samples were dried under sunlight to remove residual surface moisture. The mechanically induced cracks in the cylindrical specimens were analyzed using ImageJ software to quantify crack geometry, including width, length, and estimated area, as summarized in Table 1. Cylinder 1 and Cylinder 2 exhibited distinct crack characteristics due to controlled variations in the applied compressive load during cracking. Cylinder 1 was subjected to a slightly higher load, resulting in wider and darker cracks, which indicate larger crack openings and greater surface damage. In contrast, Cylinder 2 experienced a lower applied load, leading to narrower and lighter cracks, corresponding to less severe surface damage. These intentional variations were introduced to simulate different levels of crack severity, enabling the evaluation of the MICP treatment's performance under varying crack conditions that resemble real field scenarios. Cracked and uncracked specimens were subsequently transported to the Environmental Laboratory at Universiti Teknologi Malaysia (UTM) for treatment and further testing.

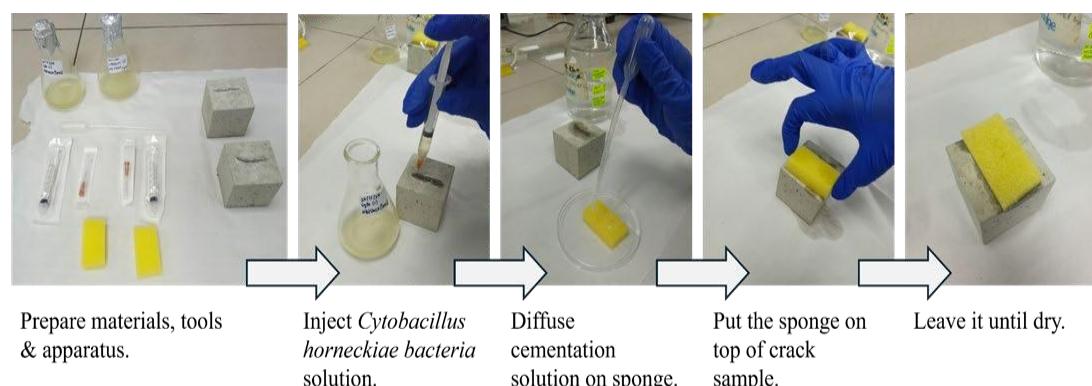
Figure 2. MICP treatment using Combined Injection Diffusion Method (CIDM)

The crack repair process using Microbially Induced Calcium Carbonate Precipitation (MICP) was performed using a combined injection and diffusion method (CIDM) as illustrated in Figure 2. The materials prepared for the treatment included *Sporosarcina pasteurii* broth culture, a 0.5 M cementation solution, cracked cube and cylindrical mortar specimens, a 3 mL syringe, and sterilized sponge pieces. Each treatment cycle began by injecting 1 mL of the active *S. pasteurii* culture directly into the cracks using the syringe, ensuring thorough bacterial penetration into the fissures. This was followed by the application of 2.5 mL of the cementation solution, dispensed onto a sponge and placed over the crack to allow passive diffusion of calcium ions. The procedure combined bacterial inoculation with nutrient delivery, enhancing calcium carbonate precipitation within the crack voids. A total of six treatment cycles were performed, with each cycle consisting of bacterial injection followed by nutrient application and a drying interval of 30–45 minutes to ensure stable deposition. This process was repeated daily over 14 consecutive days. Upon completion, treated specimens were visually inspected, and the extent of calcium carbonate formation within the cracks was recorded to assess the sealing efficiency.

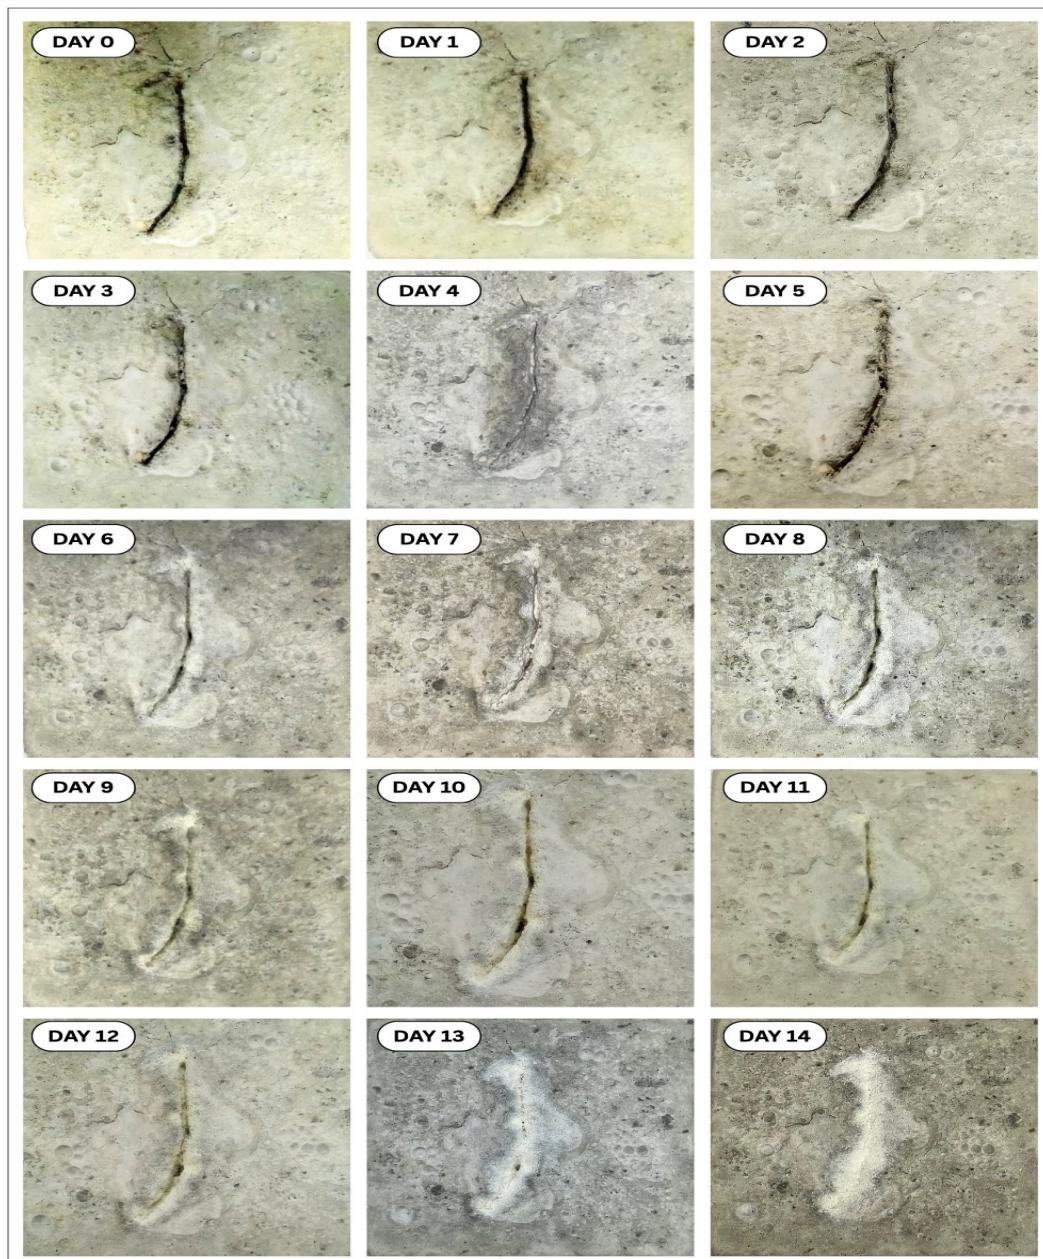
Figure 3. MICP crack repair progress using *Sporocarcina Pasteurii* bacteria

The surface healing and crack closure of both cube and cylindrical mortar specimens treated with Microbially Induced Calcium Carbonate Precipitation (MICP) using the Combined Injection and Diffusion

Method (CIDM) were visually monitored and are presented in Figure 3 for cube sample and Figure 4 for cylindrical sample. The healing process was evaluated and analysed using J software over the 14-day period (Figure 5), revealing a progressive and systematic deposition percentage of calcium carbonate within the cracks. Mineralization was observed to initiate at the lower regions of the fissures and gradually advanced upward, a pattern likely influenced by gravity-assisted sedimentation of the bacterial solution and calcium source. This directional healing is consistent with earlier MICP studies, such as Shen *et al.* [18], which also noted that CaCO_3 tends to accumulate first at the base of vertical cracks before filling laterally and upwards. By Day 5, untreated control specimens showed little to no change in surface appearance, with cracks remaining visibly open and unaltered. In contrast, the MICP-treated specimens exhibited early signs of crack bridging, with partial filling and a reduction in crack width. By Day 10, significant crack coverage was observed in the treated samples, indicating sustained microbial activity and ongoing mineral deposition. By Day 14, the cracks were fully sealed, and the surface was uniformly coated with white calcite precipitates, confirming the completion of the healing cycle.

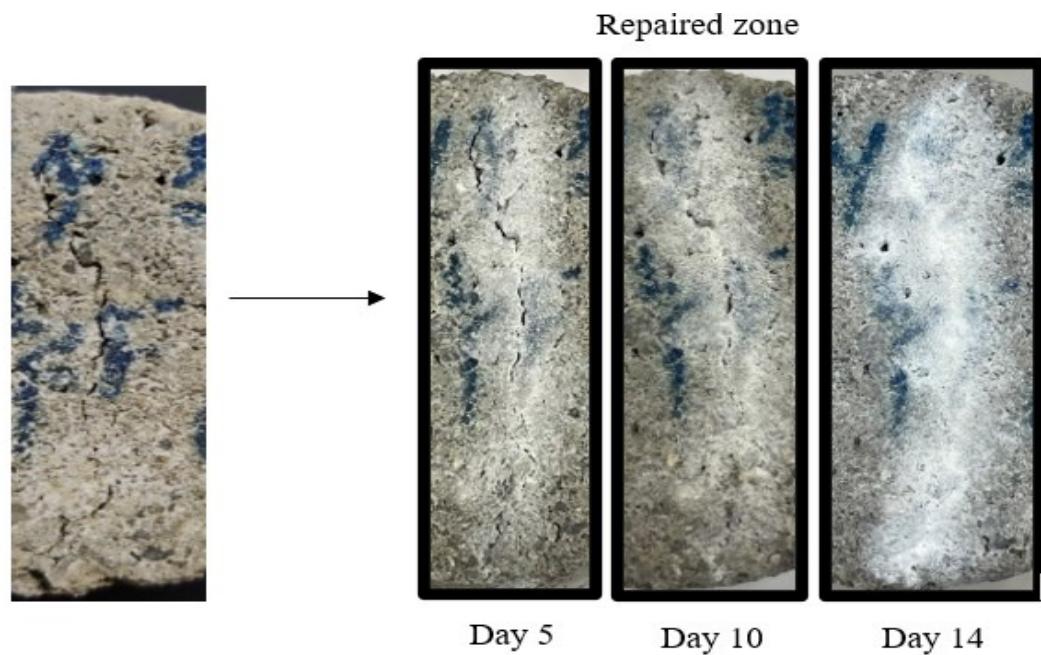
Figure 4. Surface changes of samples with CIDM at 5-day, 10-day and 14-day intervals, for cylindrical mortar

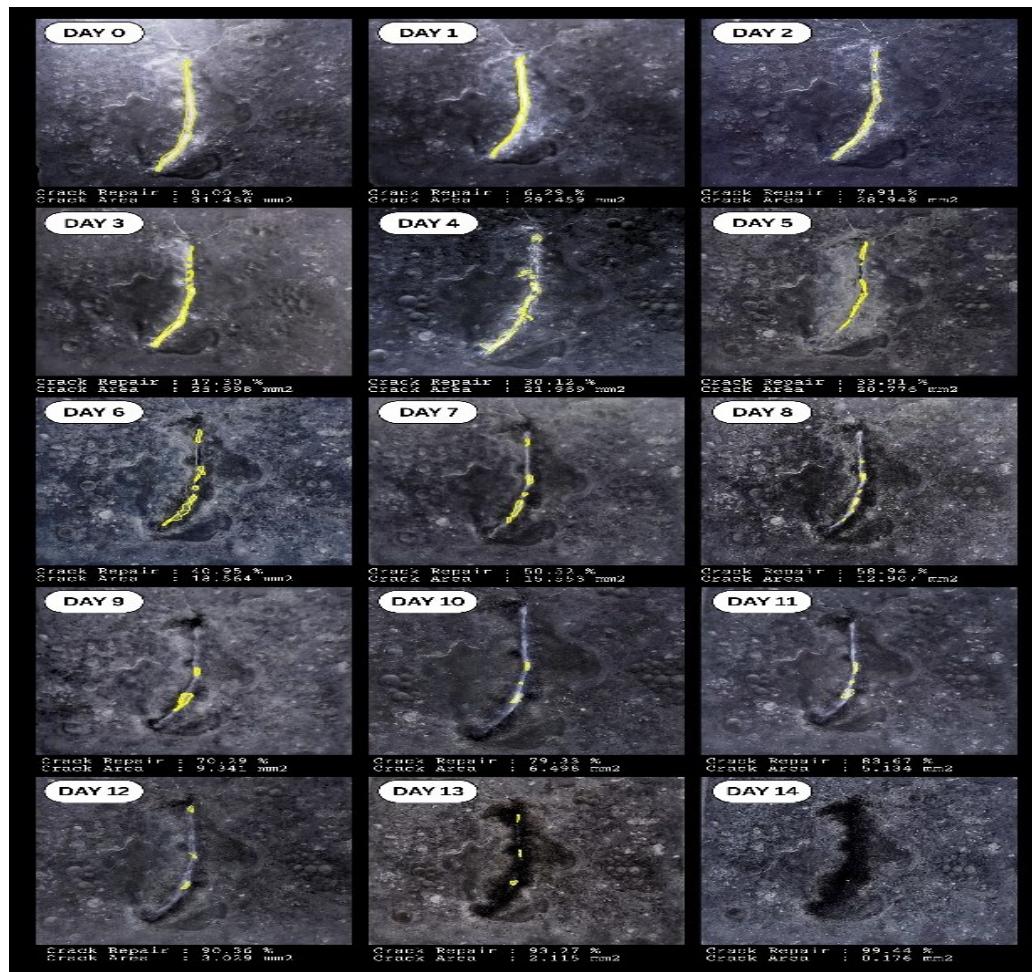
Figure 5 The crack repair progress percentage captured by ImageJ software

Compared to previous investigations utilizing direct injection or immersion techniques, the CIDM approach demonstrated enhanced efficiency in crack healing. For instance, Xiang *et al.* [19] reported partial crack filling over a 28-day period using conventional injection methods. In contrast, our CIDM-based treatment achieved full surface healing in half the time. This accelerated healing can be attributed to the hybrid nature of the CIDM, which combines pressure-driven injection with passive diffusion, thereby improving the penetration and retention of bacterial and nutrient solutions within the crack matrix. The dual-mechanism delivery ensures more uniform distribution and sustained microbial colonization, enhancing the spatial extent of CaCO_3 precipitation [20]. Furthermore, the effectiveness of CIDM in healing both cube and cylindrical specimens illustrates its adaptability to different geometries and crack orientations. The uniform sealing achieved at both macro- and micro-scales also indicates that the technique is suitable for addressing complex crack networks, which are typically more challenging to treat using traditional methods. The visual evidence of progressive healing, accompanied by complete mineral coverage by Day 14, underscores the robustness of CIDM as a self-healing strategy. In terms of environmental performance, this study advances the application of MICP by minimizing chemical waste and reducing the need for synthetic repair materials. Unlike epoxy or polymer-based systems that may pose environmental hazards, MICP is inherently sustainable and compatible with cementitious matrices. Moreover, the success of CIDM in facilitating surface-level restoration and internal crack sealing without the need for invasive or high-energy processes further supports its viability for in-situ repair applications. [21].

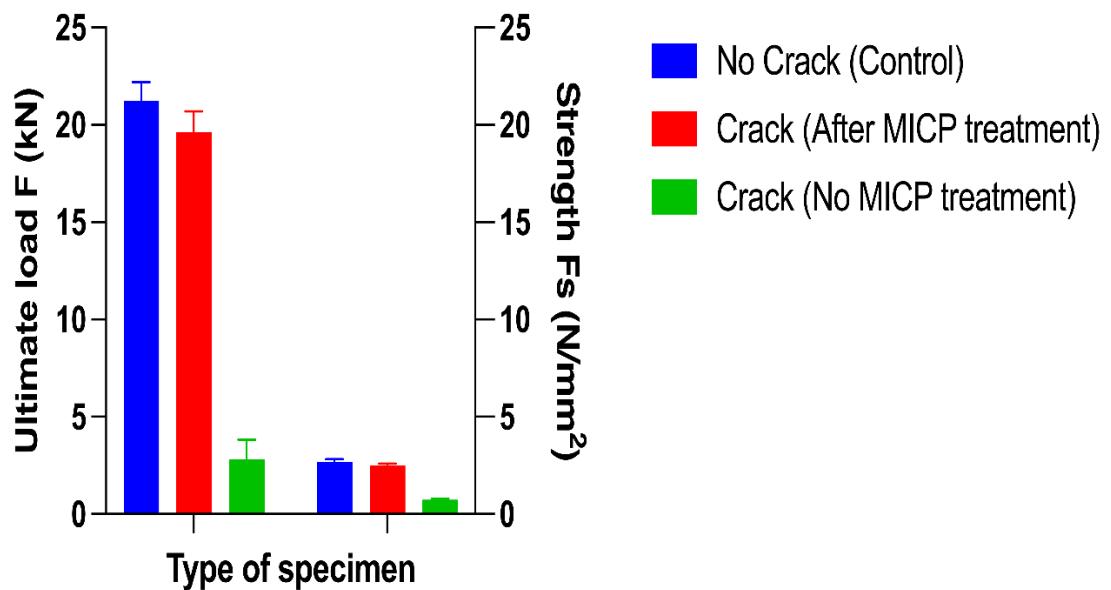
Figure 6. Comparison splitting tensile strength between no crack (control), cracked (after MICP treatment), cracked (No MICP treatment)

The splitting tensile strength test was conducted to assess the mechanical restoration achieved through Microbially Induced Calcium Carbonate Precipitation (MICP) treatment. Two cylindrical mortar specimens, one uncracked (control) and one cracked and subsequently treated were evaluated before and after repair, as depicted in Figure 3(a) and Figure 3(b). The results, summarized in Figure 6, reveal a distinct difference in both ultimate load capacity (F , kN) and calculated splitting tensile strength (f_s , N/mm 2) between the two specimens. The uncracked control sample exhibited an ultimate load-bearing capacity of 22.24 kN and a corresponding tensile strength of 2.83 N/mm 2 . In comparison, the MICP-treated sample reached 19.59 kN and 2.49 N/mm 2 , respectively, indicating a recovery of approximately 88.1% of the original structural strength. This result demonstrates that the MICP process was effective in re-establishing mechanical integrity despite the presence of prior damage. The partial restoration in tensile strength is consistent with findings from Nasser *et al.* [22], who reported recovery rates of 80–90% in MICP-treated mortar, emphasizing that even with minor strength deficits, the structural continuity and durability of the material can be substantially enhanced. The observed reduction in load capacity may be attributed to heterogeneity in mineral deposition and limited bonding at the crack interface factors also highlighted in studies by Shi *et al.* [23] and Omoregie *et al.* [24], which showed that inconsistencies in calcite growth and surface adhesion can slightly diminish the tensile performance of repaired zones. Nonetheless, the 88% recovery achieved in this study is mechanically significant and supports the interpretation that MICP can serve as an effective self-healing mechanism. The precipitation of calcium carbonate within the crack voids not only bridges the fractured surfaces but also increases the internal cohesion of the concrete matrix. This is in line with observations by Bandyopadhyay *et al.* [25], who demonstrated that bacterial urease activity enables crystal formation that mimics natural cementitious bonds. Moreover, the use of the combined injection and diffusion method (CIDM) likely contributed to the uniform distribution of bacteria and nutrients, enhancing mineral formation and crack closure throughout the depth of the fissure. This approach improves upon conventional injection methods by addressing internal damage zones that are otherwise inaccessible. In summary, while the MICP-treated specimen did not fully match the mechanical performance of the uncracked control, the high retention of tensile strength and load-bearing capacity confirms the viability of MICP as a sustainable and functionally reliable repair strategy. These findings reinforce the broader potential of bio-based crack healing technologies in extending the service life and resilience of concrete infrastructure.

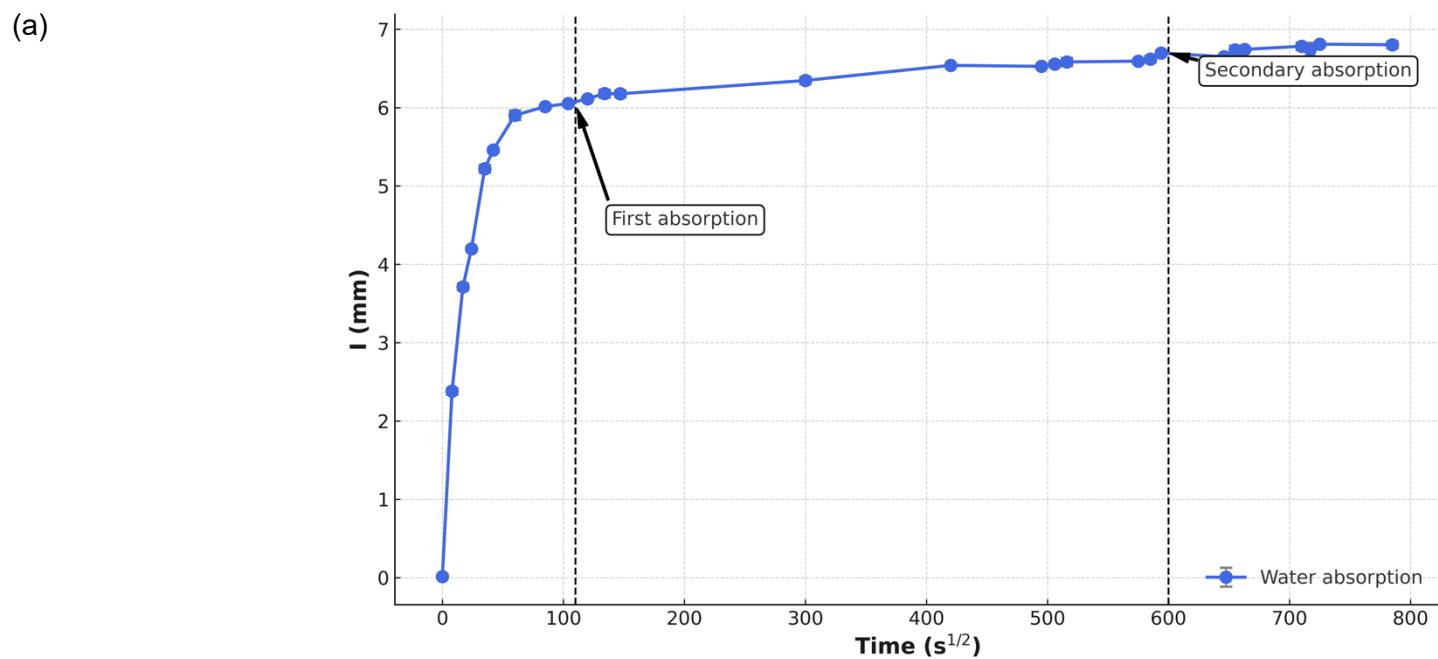
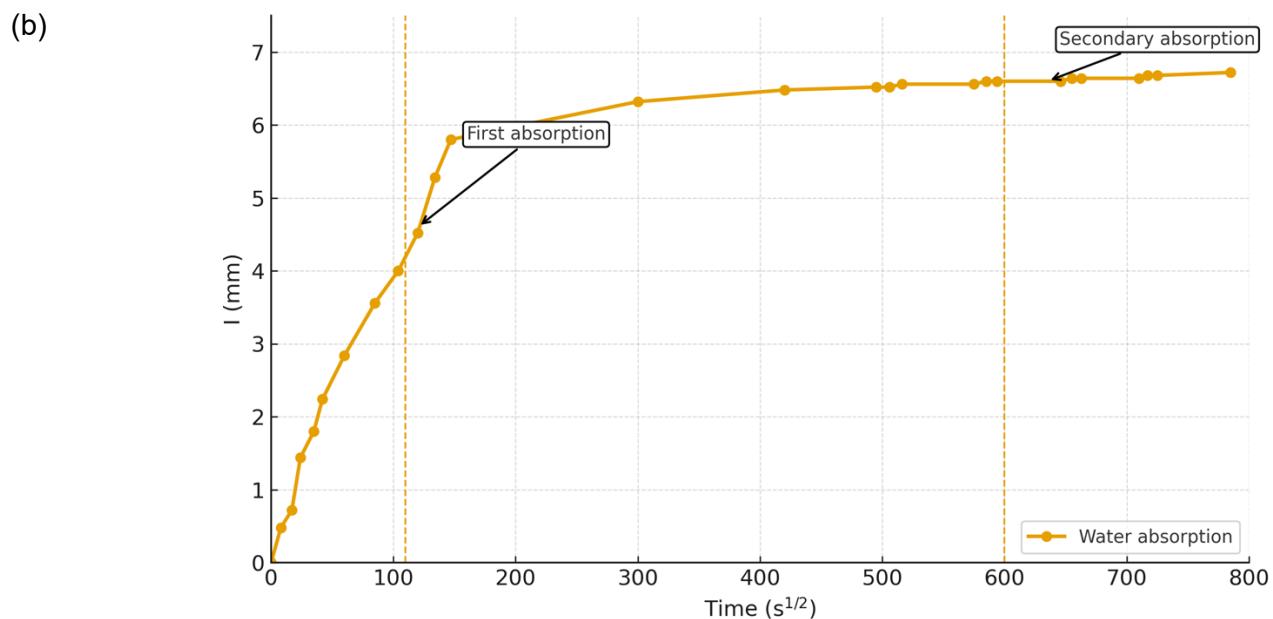
Figure 7. Water absorption rate of (a) MICP treated cube mortar and (b) Control (uncracked cube mortar)

The water absorption performance of MICP-treated cracked mortar was evaluated against uncracked mortar to assess the impact of bacterial treatment on permeability. The absorption characteristics for both specimen types, illustrated in Figure 7 reflect the distinct differences in microstructural porosity and surface sealing capacity. The treated sample demonstrated a two-phase absorption profile characteristic of capillary transport in porous media. During the initial phase, the treated cracked mortar showed a relatively steep slope ($0.0206 \text{ mm}^2/\text{s}$), with a moderate-to-strong linear correlation ($R^2 = 0.8069$), suggesting rapid water ingress through accessible surface pores and partially filled microcracks. This behavior is consistent with early-stage absorption in MICP-treated specimens reported by Yehya and Rice [26], who observed that partially healed cracks exhibit transient high permeability before mineral saturation stabilizes flow. Transitioning into the secondary absorption phase, the absorption rate significantly decreased to $0.0009 \text{ mm}^2/\text{s}$, with the correlation coefficient rising to 0.9825 . This strong linearity indicates that water uptake became progressively limited as the microstructure approached saturation, likely due to the deposition of calcium carbonate narrowing or sealing internal capillary pathways. The reduction in slope confirms the efficacy of microbial precipitation in improving water resistance, although minor residual flow was still evident suggesting incomplete sealing of microcracks or inconsistent mineral deposition within deeper fissure zones. Similar outcomes were noted by Chen *et al.* [27], where MICP treatments achieved substantial but not total impermeability, with final absorption rates remaining slightly above those of intact concrete.

The uncracked mortar exhibited a distinctly different absorption behavior, characterized by higher predictability and overall lower permeability. The initial absorption rate was steeper ($0.03607 \text{ mm}^2/\text{s}$), and the correlation coefficient was nearly perfect ($R^2 = 0.9932$), indicating a highly uniform capillary-driven uptake limited to surface porosity. As the saturation point was approached, the secondary absorption rate dropped sharply to $0.0007466 \text{ mm}^2/\text{s}$, accompanied by a strong correlation ($R^2 = 0.9762$), reaffirming the integrity of the specimen and the minimal pathways available for continued ingress. Compared to the treated cracked sample, the uncracked mortar absorbed less water overall and transitioned more sharply between the initial and secondary phases. These results underscore the natural impermeability of intact concrete, where pore connectivity is minimal and tortuosity inhibits sustained water transport. These findings align with baseline expectations established in the work of Lekundayo [28], which emphasized the inherently low sorptivity of high-quality, uncracked mortar. The comparative analysis between treated and uncracked mortars highlights several key observations. Both samples demonstrated a clear two-phase absorption pattern, but the treated cracked mortar exhibited greater variability in the initial stage, as indicated by its lower R^2 value. This deviation likely reflects residual microcracks or heterogeneities in bacterial or nutrient distribution during the MICP treatment process. Although the secondary absorption rates for both samples were similar in order of magnitude, the treated mortar still exhibited slightly higher water uptake, suggesting partial not complete recovery of impermeability.

Nevertheless, the reduction in absorption rate from $0.0206 \text{ mm/s}^{1/2}$ to $0.0009 \text{ mm/s}^{1/2}$ in the treated mortar demonstrates the effectiveness of the MICP process in sealing capillary voids. When compared to values reported for untreated cracked concrete (often exceeding $0.005 \text{ mm/s}^{1/2}$ in secondary absorption), the treated specimens performed favorably, reaffirming the contribution of *Sporosarcina pasteurii*-mediated calcite precipitation in permeability mitigation. Studies by Jongvivatsakul et al. [29] and Gao et al. [30] similarly noted that MICP treatments result in 60–80% reductions in water absorption compared to their untreated cracked counterparts. However, the marginal difference between the treated and uncracked specimens in the secondary phase highlights the limitations of the current treatment configuration. Variability in bacterial colonization, crack depth, and mineral uniformity may explain the incomplete sealing effect [31]. The presence of residual unfilled pathways, particularly in deeper crack networks or at the interface between the precipitate and matrix, could sustain low levels of water ingress, limiting the complete restoration of barrier properties [32]. The water absorption data confirms that MICP treatment enhances the resistance of cracked mortar to water penetration, offering a bio-based alternative to traditional sealants. While not fully restoring impermeability to the level of uncracked concrete, the treatment significantly reduces capillary action and slows the rate of water ingress an essential feature for increasing the service life of repaired structures exposed to moisture-driven deterioration mechanisms. Future improvements in treatment efficiency may be achieved through the optimization of bacterial concentration, nutrient composition, and treatment duration. Multicycle or staged nutrient delivery, or integration with additional sealing agents, may further enhance crack closure and minimize residual flow paths. The use of imaging techniques such as micro-CT or 3D profilometry could also assist in verifying sealing continuity and improving treatment targeting in heterogeneous crack geometries.

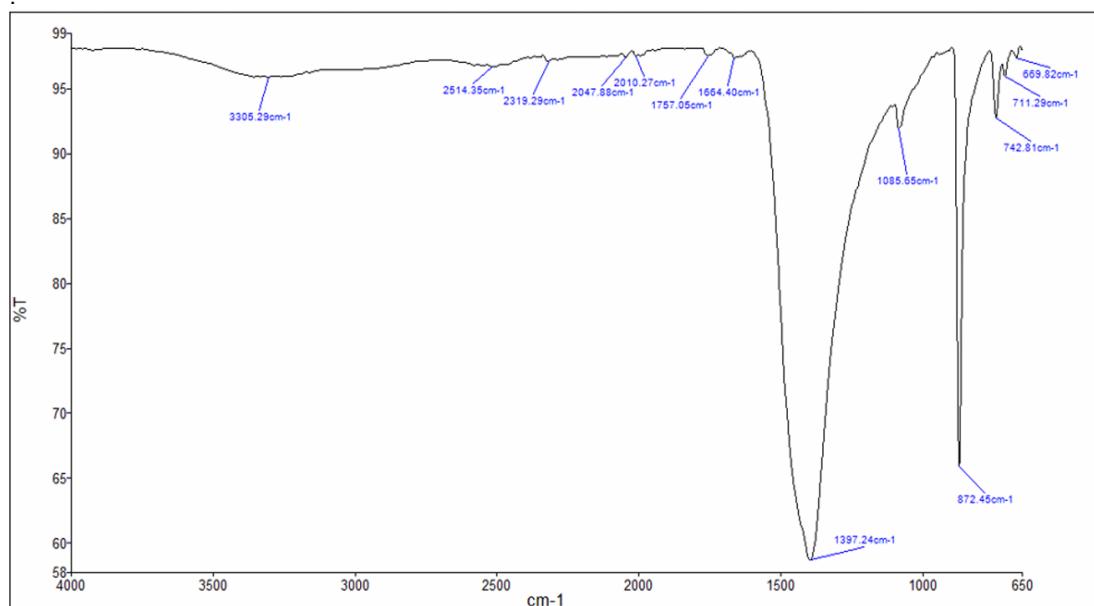
Figure 8. Fourier Transformed Infrared Spectroscopy (FTIR) spectrum

The Fourier Transform Infrared (FTIR) spectroscopy was performed to identify the functional groups associated with the calcium carbonate precipitate produced by *Sporosarcina pasteurii*. The spectral profile, shown in Figure 8, reveals the simultaneous presence of organic biomolecules and inorganic carbonate both of which are essential to the microbial-induced precipitation mechanism. A broad absorption band observed at 3305.29 cm^{-1} corresponds to O–H and N–H stretching vibrations, typically found in hydroxyl and amine groups. These functional groups are prevalent in proteins and polysaccharides, which form part of the bacterial cell membrane and extracellular polymeric substances (EPS). Their presence in the precipitate confirms active microbial involvement in the mineralization process. This is in agreement with previous studies which demonstrated that bacterial EPS not only supports microbial viability but also provides chemically active sites for calcium binding and nucleation [33–35]. Peaks detected at 2514.35 cm^{-1} and 2319.29 cm^{-1} are indicative of asymmetric CO_2 stretching vibrations. These are likely residual signatures from urease-catalyzed urea hydrolysis a critical biochemical step that increases pH and facilitates calcium carbonate supersaturation. Similar peaks were reported by Ojha et al. [36], who noted that the temporary entrapment of CO_2 within the biofilm microenvironment is essential for carbonate precipitation to initiate effectively. Additional absorption features at 1757.05 cm^{-1} and 1664.40 cm^{-1} represent carbonyl (C=O) stretching and the amide I band, respectively. These bands are typically associated with protein secondary structures, particularly enzymes like urease. Their presence corroborates the catalytic role of microbial proteins in accelerating carbonate formation. Krajewska et al. [37] also linked amide I bands to active ureolytic processes, confirming that microbial proteins not only hydrolyze urea but also enhance surface reactivity for mineral deposition.

The 1085.65 cm^{-1} peak, attributed to C–O stretching vibrations, suggests the presence of polysaccharides. These are a key component of bacterial EPS and act as scaffolds or templates for mineral nucleation. Recent findings by Niu et al. [38] emphasized that such functional groups improve the mechanical adhesion of calcium carbonate crystals within crack voids and influence the morphology of precipitated minerals. This contributes directly to the sealing and bonding strength observed in MICP-treated concrete. Additional minor bands between 2000 – 2100 cm^{-1} and at 1397.24 cm^{-1} suggest the presence of alkynes and aromatic or carboxyl-related groups, which may originate from bacterial metabolites or amino acid residues. Although not primary agents in mineralization, these functional groups may regulate local chemical environments and support the formation of stable crystal phases. Crucially, well-defined peaks at 742.81 cm^{-1} , 711.29 cm^{-1} , and 872.45 cm^{-1} confirm the presence of calcite—a stable and mechanically favorable polymorph of calcium carbonate. The peak at 872.45 cm^{-1} , corresponding to out-of-plane C–H bending, is a hallmark of calcite lattice vibrations. This aligns with previous FTIR studies by Zhang et al. [39] and Zhu et al. [40], which found that calcite formation, as

opposed to vaterite or aragonite, results in more durable and cohesive crack sealing in concrete matrices. Taken together, the FTIR spectrum provides molecular-level evidence that *S. pasteurii* facilitated the precipitation of structurally significant calcium carbonate through ureolytic activity. The detection of proteins, polysaccharides, and stable carbonate phases confirms the dual biological and mineral nature of the repair. Moreover, the spectral consistency with prior studies strengthens the conclusion that MICP is not only an environmentally benign process but also a functionally robust solution for restoring the integrity of cracked concrete through biochemical self-healing.

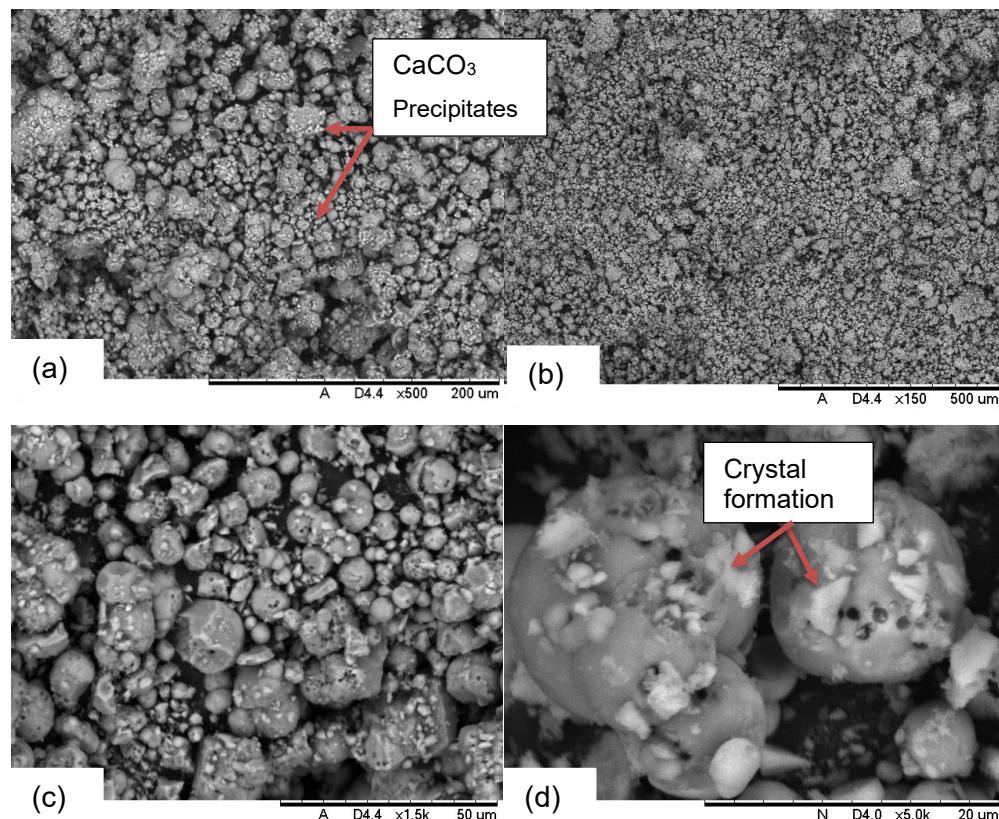
Figure 9. SEM images illustrates the surface morphology of the calcium carbonate formed for the crack repair

The morphological and compositional features of calcium carbonate precipitates formed through Microbially Induced Calcium Carbonate Precipitation (MICP) were characterized using Scanning Electron Microscopy (SEM) and Energy-Dispersive X-ray Spectroscopy (EDX). SEM imaging provided direct evidence of mineral accumulation within the cracked regions of treated specimens. At 150 \times magnification Figure 9 (a), a homogeneous and continuous layer of mineral deposits was observed across the previously damaged surface. The presence of a cohesive mineral film bridging the fissures implies effective bacterial colonization and mineral deposition along the crack walls. This observation is consistent with Huang *et al.* [41], who reported similar surface morphologies in concrete specimens treated with ureolytic bacteria, indicating the sealing capability of biologically derived calcium carbonate. Higher magnifications revealed more intricate microstructural features. At 500 \times magnification, Figure 9 (b), granular clusters of calcium carbonate were observed, forming interconnected networks along the crack plane. These features suggest not only surface coverage but also subsurface penetration of the mineral into the void structure. Such clustered morphologies were also reported by Dong *et al.* [42], who linked this growth pattern to enhanced fracture bridging and reduced permeability in MICP-repaired specimens.

At 1500 \times magnification Figure 9 (c), the growth of rounded and polygonal CaCO_3 aggregates became prominent, suggesting progressive stages of biomineral development. These morphologies reflect an advanced state of nucleation and crystal consolidation, likely resulting from the repetitive 14-day bacterial and nutrient treatment cycle. Similar morphologies have been identified in earlier studies in such formations with high-efficiency microbial healing processes in cementitious matrices [43–45]. Finally, at 5000 \times magnification Figure 9 (c), well-defined rhombohedral crystals characteristic of calcite were distinctly visible. These structures appeared densely packed and geometrically regular, indicating phase-pure mineral growth. Rhombohedral crystal forms are a well-established signature of microbial calcite precipitation [46, 47]. The presence of such defined crystals supports the conclusion that the MICP treatment not only sealed cracks but also contributed to microstructural reinforcement by forming a durable mineral phase within the fracture. The evolution from diffuse, early-stage deposits to

consolidated crystal networks across increasing magnifications reinforces the effectiveness of the Combined Injection and Diffusion Method (CIDM). This technique ensured that both bacterial culture and cementation solution reached and reacted within the entirety of the crack void, enabling uniform and progressive mineralization.

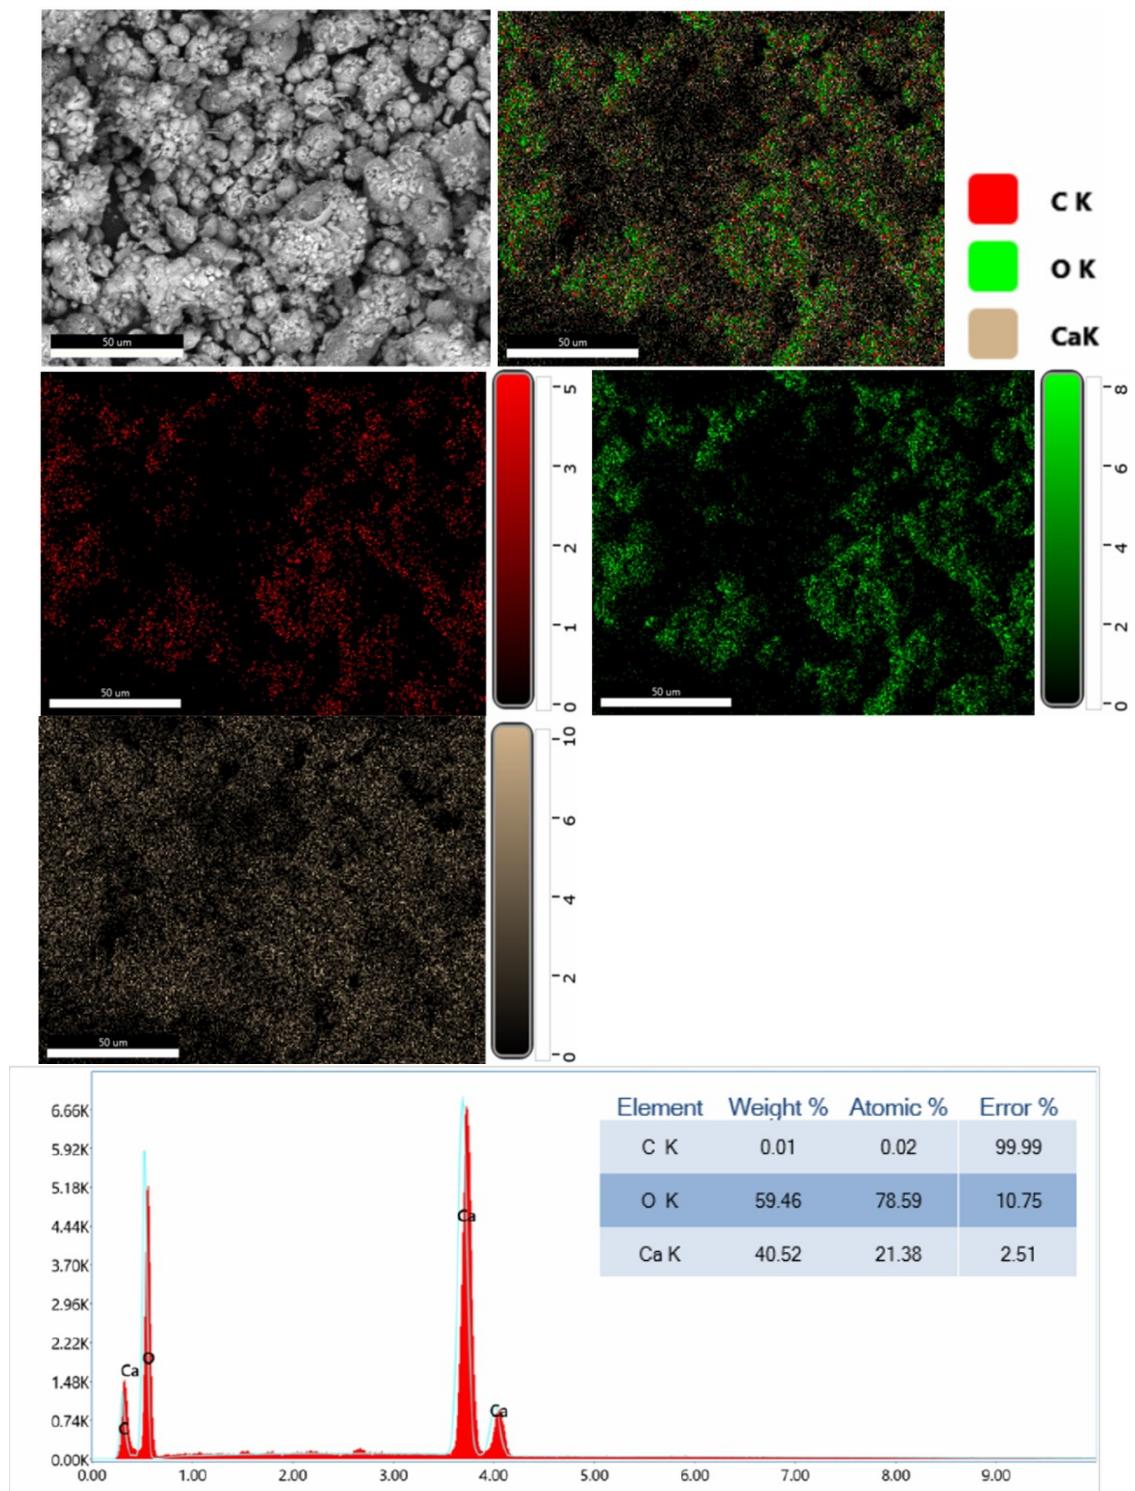
Figure 10. Energy Dispersive X-ray (EDX) results for elemental, (a) composition and (b) mapping

To validate the chemical identity and purity of the precipitated material, EDX analysis was conducted on the mineral deposits observed in SEM. Spectral data from Figure 10 revealed a dominant presence of calcium (Ca) and oxygen (O), which accounted for 40.52% and 59.46% by weight, respectively. Atomic percentages followed a similar trend, with Ca at 21.38% and O at 78.59%. These ratios strongly correspond to those reported for calcium carbonate (CaCO_3), particularly the calcite polymorph [48]. The detection of carbon (C) was negligible (0.01% by weight, 0.02% atomic), which may be attributed to instrumental limitations in detecting light elements or to surface preparation artefacts such as coating interference or beam-induced volatilization. Importantly, the near absence of extraneous elements (e.g., heavy metals or silicates) confirms the purity of the mineral phase and suggests minimal contamination from the cement matrix or external sources. Elemental mapping further confirmed the uniform distribution of Ca and O across the treated region, with no signs of aggregation or compositional inhomogeneity. This homogeneity is critical for the mechanical performance of the repair, as patchy or localized mineralization may lead to stress concentration and premature failure. Similar uniformity in elemental composition has been associated with improved bonding and long-term durability in studies by Sun *et al.* [49] and Huang *et al.* [50]. The consistency between the EDX findings and SEM morphologies supports the interpretation that the precipitate was phase-pure, well-structured calcium carbonate formed through biologically driven processes. The purity and distribution of Ca and O, combined with the distinct rhombohedral crystal habit observed via SEM, confirm that the predominant mineral phase is calcite thermodynamically the most stable form of CaCO_3 . This contrasts with vaterite or aragonite, which are less stable and often observed in uncontrolled or early-stage MICP.

The microstructural and elemental features observed in this study are highly consistent with previous MICP research, confirming both the reproducibility and reliability of bio-mediated crack healing. Likewise, the high Ca/O ratio observed in the EDX analysis is nearly identical to that found in the work of Omorogie *et al.* [51], who demonstrated that phase-pure calcite formation is critical for long-term stability and chemical compatibility with concrete substrates. Moreover, the absence of organic or amorphous phases

in the EDX spectra suggests that the repair process reached full mineral maturity by the end of the 14-day treatment cycle. This is particularly significant when compared to early-stage carbonate capacity studies, such as those by Liu *et al.* [52], where insufficient carbonic capacity led to weak interface bonding and reduced mechanical recovery. In contrast, the current study's SEM–EDX data illustrate a fully formed, spatially integrated mineral network with high phase purity and structural coherence. Together, the SEM and EDX analyses confirm that the MICP treatment, delivered through the CIDM protocol, produced dense, uniformly distributed, and chemically pure calcium carbonate precipitates within the repaired crack zones. The observed morphologies and elemental profiles correspond to phase-pure calcite with optimal microstructural integration. These findings not only validate the biochemical functionality of *S. pasteurii* in concrete crack repair but also reinforce the structural performance gains observed in mechanical tests. Compared with prior studies, the results achieved here demonstrate a high level of consistency, reliability, and applicability affirming the feasibility of MICP as a robust and sustainable strategy for cementitious infrastructure rehabilitation.

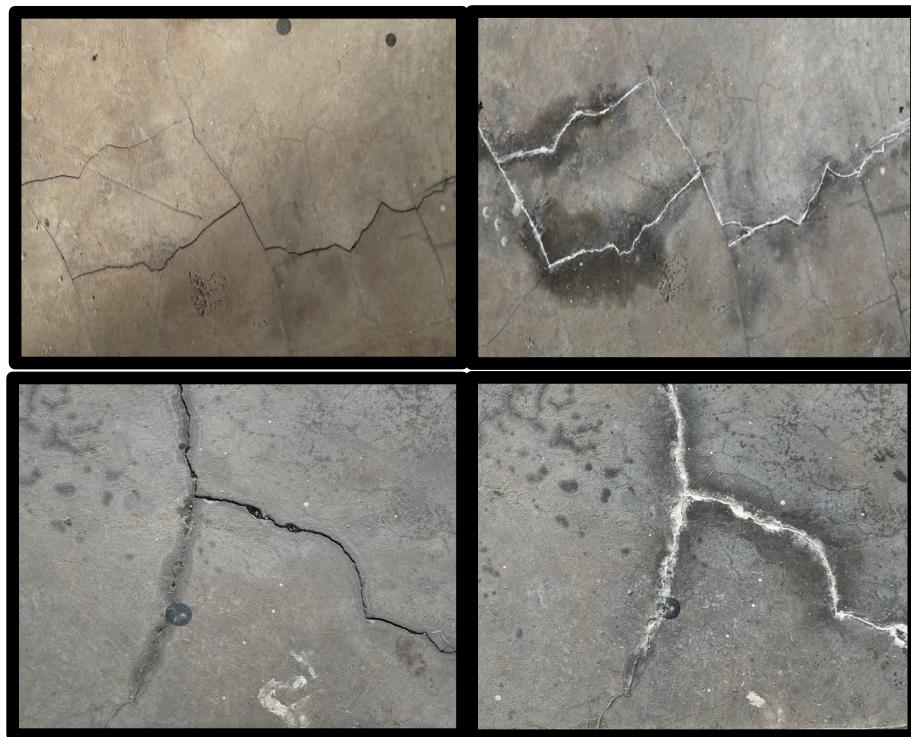
Figure 6. Surface changes of two selected cement cracked in situ before and after MICP treatment

The in-situ application of Microbially Induced Calcium Carbonate Precipitation (MICP) was carried out at UTMSPACE to evaluate the field performance of the Combined Injection and Diffusion Method (CIDM) under uncontrolled environmental conditions. Two cement surfaces with visible cracks were selected for treatment and repaired over the course of two consecutive days one surface per day Figure 11. Each surface received six full treatment cycles, including microbial injection, cementation solution diffusion via sponge contact, and resting intervals, completed within approximately 4 to 6 hours per location. Visual inspection immediately following treatment revealed distinct mineral deposits forming along the treated cracks. The presence of white crystalline material consistent with calcite was observed, closely resembling the biomineral formations seen in laboratory-treated specimens. This confirmed that the core MICP mechanisms, urease-mediated urea hydrolysis, calcium ion availability, and localized pH elevation remained active in the open-air environment. The observable reduction in crack width and the partial or complete infill of fissures demonstrated the viability of field-scale MICP implementation for near-surface crack remediation. Notably, the field treatment yielded visible mineralization and partial sealing within a single working day per crack substantially faster than the 14-day laboratory protocol. This rapid response may be attributed to the nature of surface cracks in the field, which were shallower and more exposed to air. Higher evaporation rates and increased air contact could have accelerated supersaturation and carbonate precipitation. Similar field observations were reported by Lu *et al.* [14], who found that MICP reaction kinetics can vary significantly under field conditions depending on substrate geometry, ambient temperature, and drying rates.

The delivery technique, involving manual syringe-based bacterial injection followed by nutrient diffusion through saturated sponge strips, was effective and logically simple. The approach did not require pressurized systems or automated dosing, making it especially applicable for sites with limited access to equipment or power sources. This supports the practical scalability of CIDM for real-world repairs, particularly in remote, resource-constrained, or emergency-response contexts. Comparable strategies using low-tech delivery mechanisms have also been recommended in recent applied MICP field studies [50, 53]. While initial observations confirmed mineral formation and crack coverage, long-term performance under natural weathering conditions remains unverified. Environmental exposure to moisture cycling, freeze-thaw events, ultraviolet radiation, and physical abrasion may affect the adhesion, cohesion, and structural integrity of the bio-deposited calcite. Extended monitoring and durability testing are therefore essential to evaluate the persistence of the repair under service conditions. Several researchers, including Kalawole *et al.* [54] and Jiang *et al.* [55], have emphasized the need for long-term durability validation in MICP applications before adoption in structural-grade repairs. The field trial demonstrated that CIDM-based MICP treatment is a viable, fast-acting, and low-tech method for sealing shallow cracks in cementitious surfaces. The observed in-situ calcium carbonate precipitation and visible sealing effects confirm that the key biochemical processes function effectively outside controlled laboratory settings. These results underscore the potential of MICP as a sustainable, environmentally friendly alternative to conventional repair materials for surface-level crack remediation. However, future work must focus on performance validation under prolonged field exposure to fully establish the method's structural reliability and lifecycle impact.
